Manhole Inspection Summary

Manhole # S15AA_023MH

Insp Date: **8/7/09 9:14 AM**

Location Address: **REAR OF 933 ASHBURTON ST**

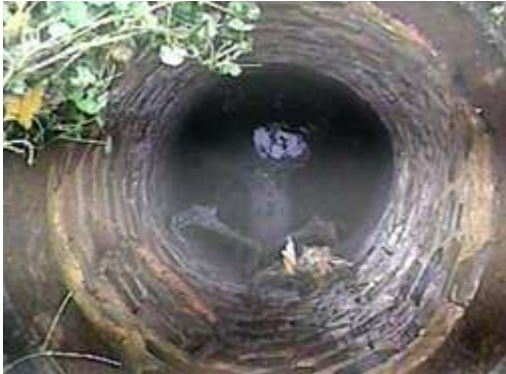
Defect 5

☒ **Evidence Of Surcharge** Depth: **7** (ft.) ☐ Active Surcharge Present

evidence of ASUR

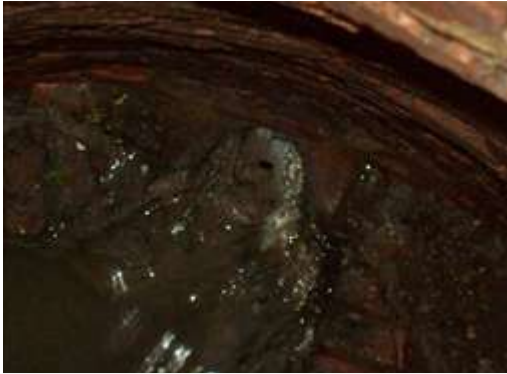
Defect 4

Condition: ☐ Sound ☐ Cracked ☐ Root Intrusion ☐ Deteriorated ☐ Leaks ☒ **Debris**

DEBRIS IN CHANNEL

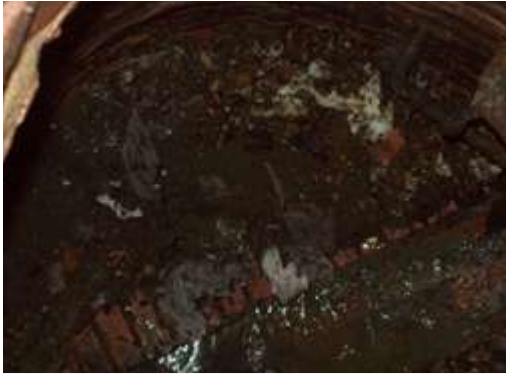
Defect 3

Condition: ☐ Sound ☐ Cracked ☐ Root Intrusion ☐ Deteriorated ☐ Leaks ☒ **Debris**

DEBRIS ON BENCH

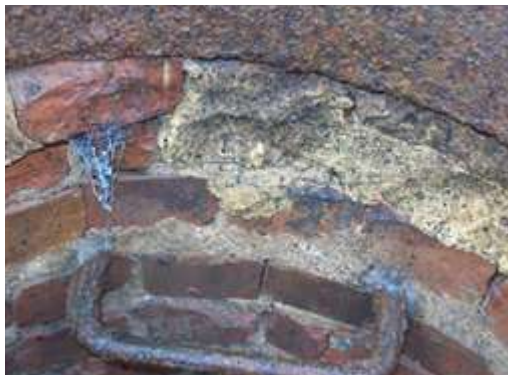
Defect 2

Condition: ☐ Sound ☐ Cracked ☐ Root Intrusion ☒ **Loose Brick** ☐ Deteriorated

Condition: ☐ Sound ☒ **Cracked** ☐ Root Intrusion ☒ **Loose Brick** ☒ **Deteriorated**

LOOSE BRICK

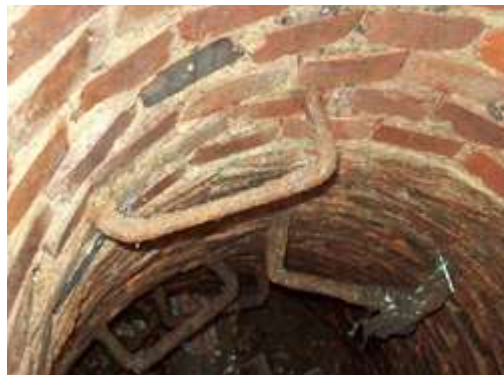
Defect 1

Count: **6** Missing: **0** ☒ **Corroded**

CORRODED STEPS

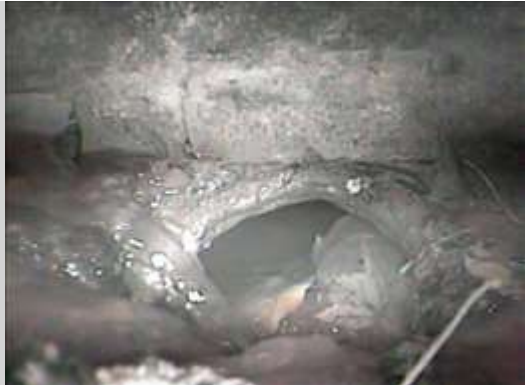
12 O'Clock Outflow

8 in. Circular Gravity Sewer
Pipe Out @ 12 O'Clock

Deposits: ☐ None ☐ Mud ☒ Sludge ☒ Debris ☐ Grease

Silt Depth: **3** (in.) Deposits Extent: **Medium**

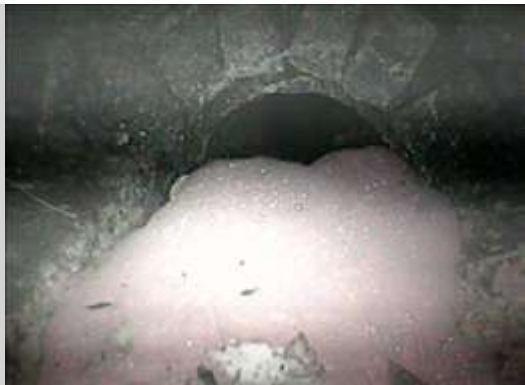
6 O'Clock Inflow

10 in. Circular Gravity Sewer
Pipe In @ 6 O'Clock

Deposits: ☐ None ☐ Mud ☒ Sludge ☒ Debris ☐ Grease

Silt Depth: **5** (in.) Deposits Extent: **Medium**
